NAVAVNSAFECEN MISHAP CODE SHEET

a. The Accident. A-4A, BUNO 137828, assigned to NAVAL AIR RESERVE TRAINING UNIT (NARTU), Los Alamitos, and piloted by LT (b) (6) USNR, (b) (6), attached to ATTACK SQUADRON SEVEN SEVEN THREE (VA-773) crashed and was destroyed in a mountainous area 295 degrees, 40 miles from Imperial Vortac, California at 1815(U) on 17 April 1968. The pilot ejected and received no injuries. There was minor damage to a mountainside in the Anza-Borrego State Park, Borrego Springs, California.

Subject: First Stage Compressor Rotor Blade Failure,
P/N 231817. J65-W16A Engine Model, S/N 617041.

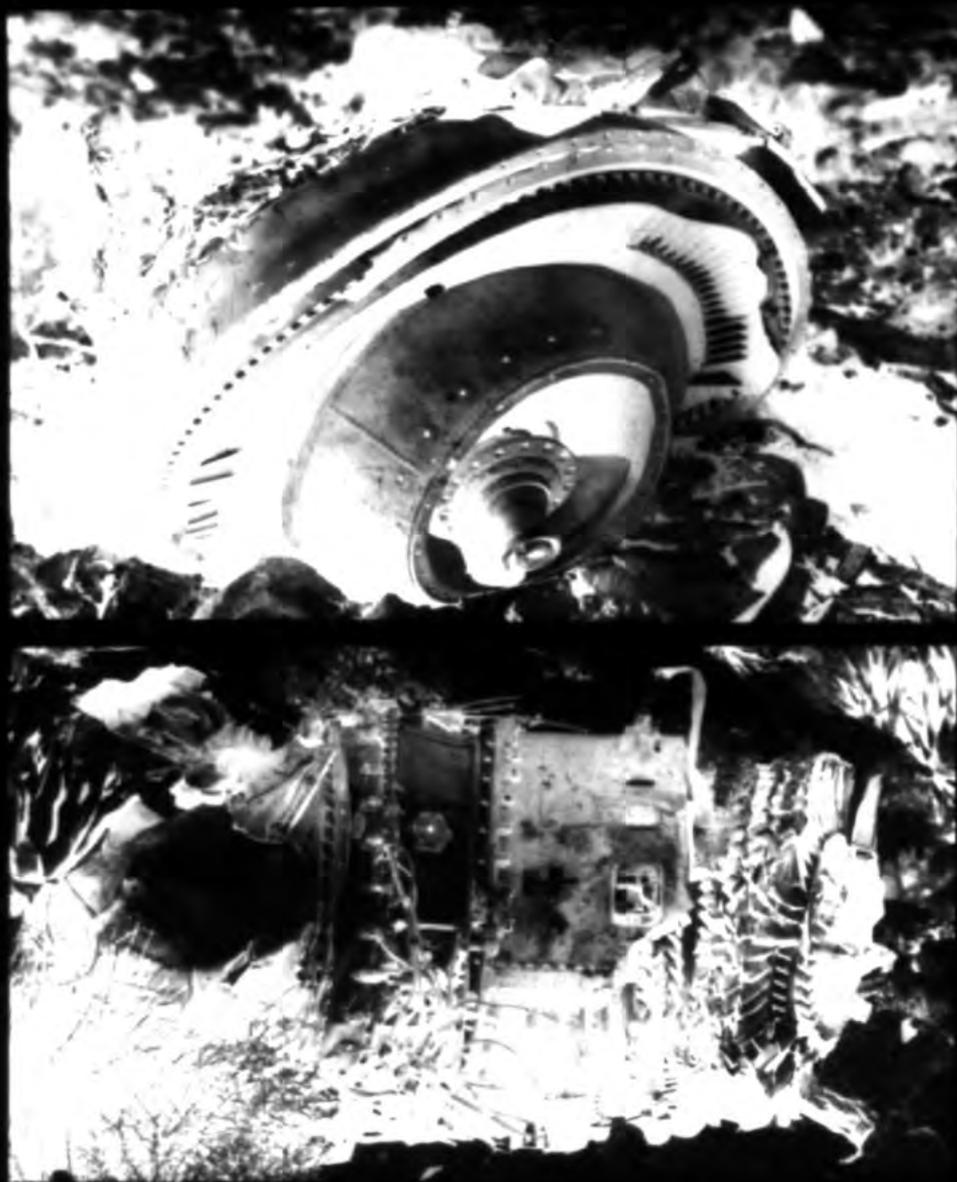
7. On 19 April 1968, the Board accompanied by the investigator from the Naval Aviation Safety Center were lead to the crash site by park rangers. The engine was found in two major pieces; the turbine section and compressor section. The compressor section exhibited low RPM on impact and considerable in-flight foreign object damage. Airframe parts were examined, none exhibited any failures or malfunctions; none had been reported by the pilot. The ejection seat and canopy were not found.

ENCLOSURE (5) COMPOSITE VIEW OF ENGINE AND TURBINE AS FOUND AT CRASH SITE.
NAS LOS ALAMITOS 3-68A, 4-17-68
A-4A, BUONO 137828, pilot (b) (6), VA-773
SPECIAL HANDLING REQUIRED LAW OPNAVINST 3750.6 SERIES

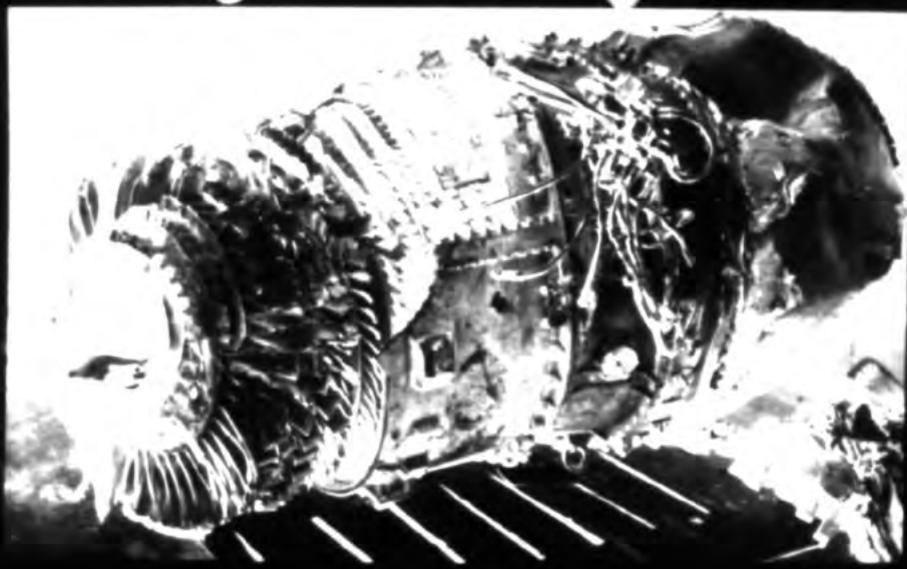
a. Engine compressor and turbine section have severe evidence of in-flight failure and damage.

ENCLOSURE (6) COMPOSITE PHOTO OF ENGINE COMPRESSOR SECTION.
NAS LOS ALAMITOS 3-68A, 4-17-68
A-4A, BUONO 137828, pilot (b) (6), VA-773
SPECIAL HANDLING REQUIRED IAW OPNAVINST 3750.6 (2-4-11)

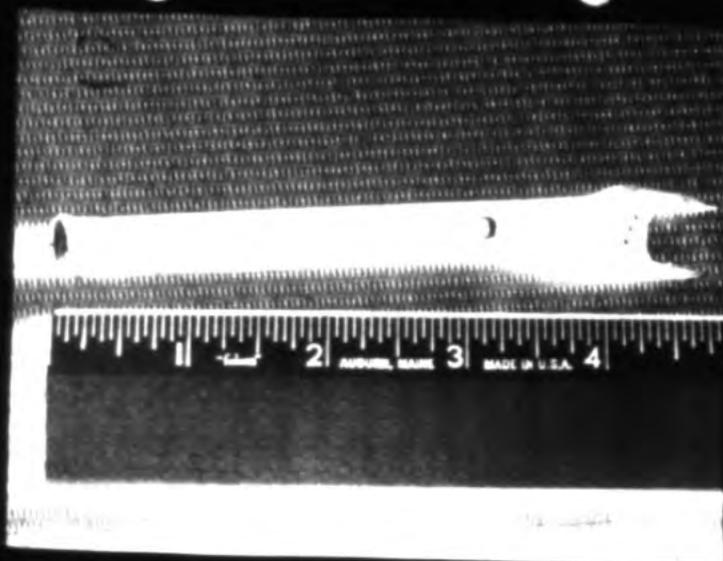
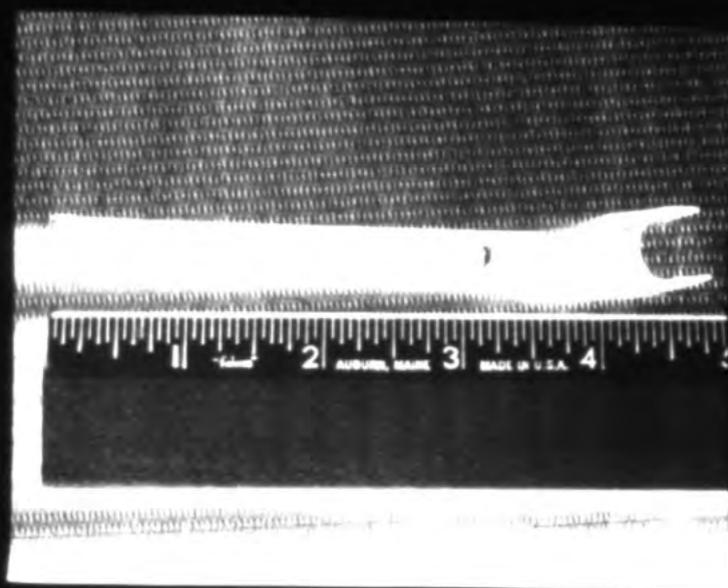
8. It was reported that a wrench was found in the wreckage at the crash site, however, the prior location of this foreign object in the engine and the relationship to the subject failure was not known. The wrench was retained by USN safety center personnel for exhibit at the overhaul activity.

4. A 7/16ths inch open end wrench approximately 4 3/4 inches long was found in the impact area of the crash site. The wrench was a Craftsman brand. The wrench was found in an unmarked/scratched condition. It was painted black and was filed, or ground thin at the wrench end. The wrench opening was 1/2 inch wide vice the 7/16ths stamped on the wrench. Three identifying dots were drilled in the base of the wrench end. The wrench was sent to NARF Alameda for examination. NARF Alameda could find no evidence on the wrench or engine to indicate the wrench was involved in the accident. NARF Alameda was unable to establish ownership or usage of the wrench. An investigation of the tools used at NAS Los Alamitos did not reveal ownership or usage of the wrench at that activity. The Board was told that the Navy does not purchase Craftsman tools and none were found in use at NAS Los Alamitos. The presence of the wrench at the crash site could have been purely coincidental, but more probably it was in the aircraft and had fallen from someone's pocket while working on, or inspecting the aircraft, at anytime during the history of the aircraft. Enclosure (10) is a photo of the wrench.

ENCLOSURE (10) WRENCH FOUND AT IMPACT POINT
NAS LOS ALAMITOS 3-68A, 4-17-68
A-4A, BUNO 137828, PILOT (b) (6)
SPECIAL HANDLING REQUIRED IAW OPNAVINST 3750.6 SERIES
